Project	A10 JUNCTIONS AND DUALLING
---------	----------------------------

Drawing Title	Existing Alignment AIR QUALITY CONSTRAINTS PLAN 200M SHEET 1 OF 2
---------------	--

Drawing Number	BESP0020-JAC-EAQ-XX-DR-LE-0001
----------------	--------------------------------

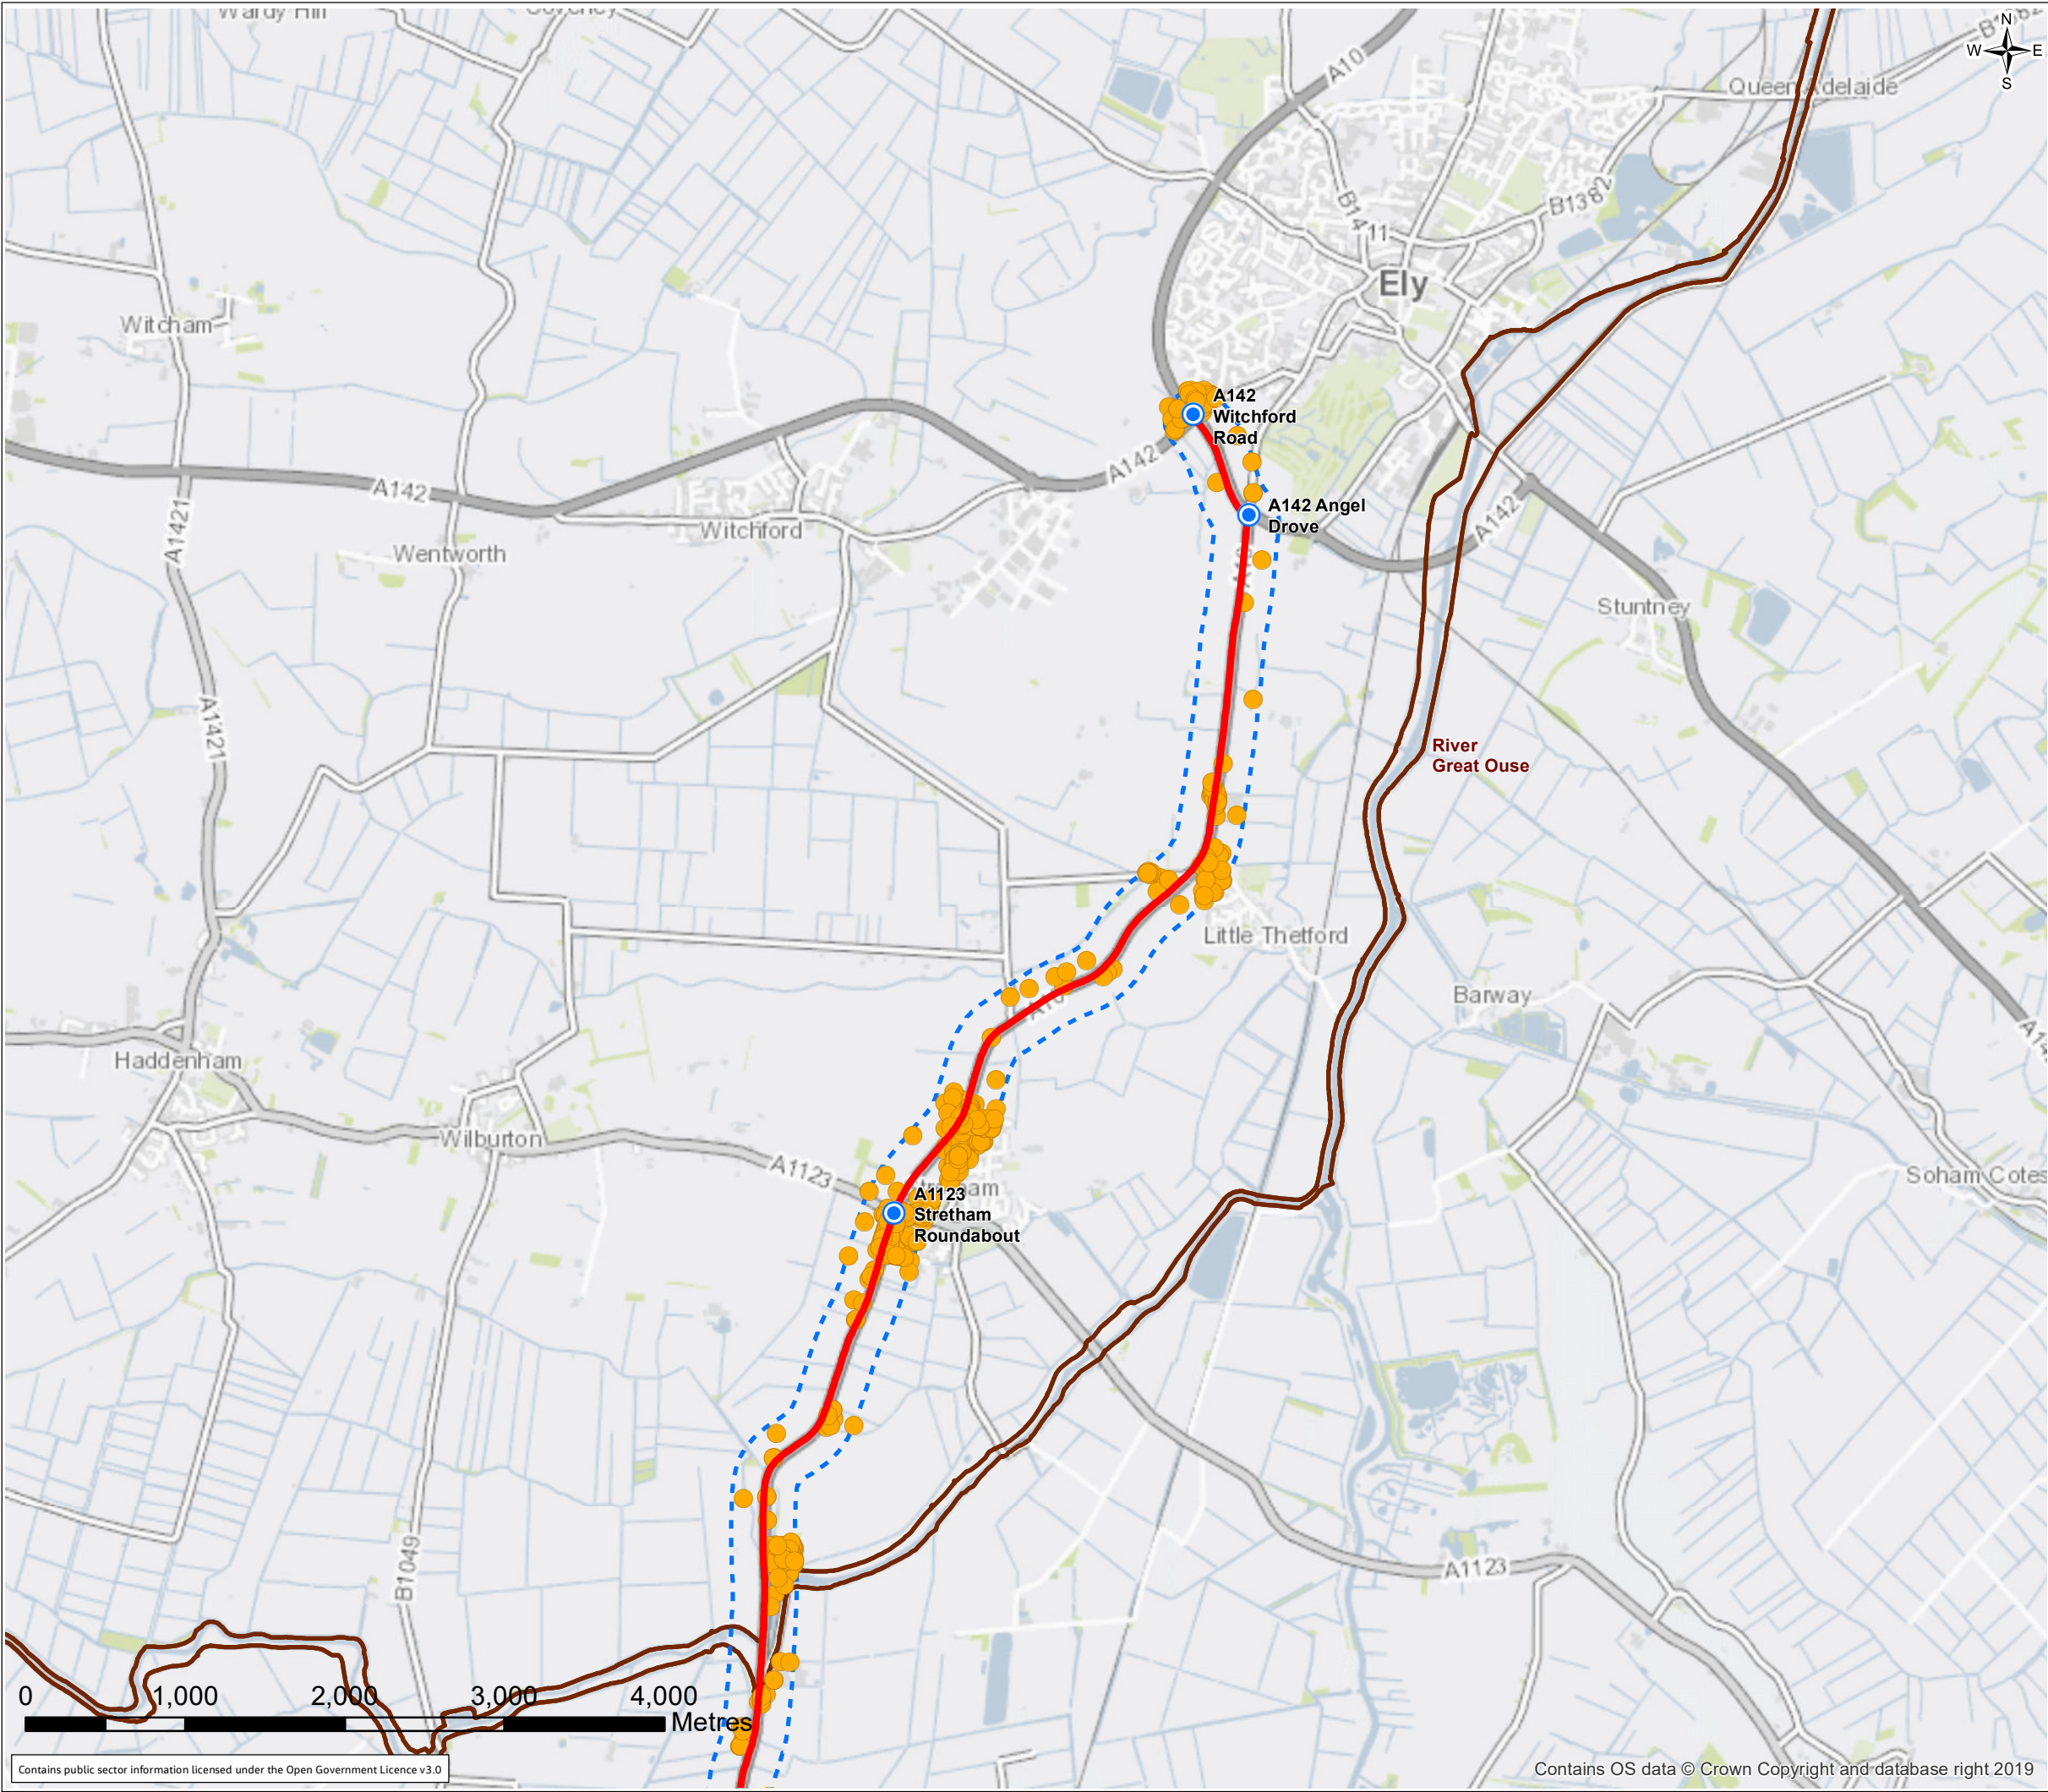
FIGURE 5

- Existing A10 alignment (no improvement)
- A10 Junction location
- Properties within 200m of existing 10 alignment
- 200m buffer around existing A10 alignment
- County Wildlife Site (Rive Great Ouse)

Note: No AQMAs within 1km of the existing A10
